No.	005-24
区分	修理
対象	マシニングセンター

製造者	新潟マシン
型式	NH1000
内容	Y軸の精度不良

【 Overview of repair machines : Y-axis accuracy failure on horizontal machining center 】

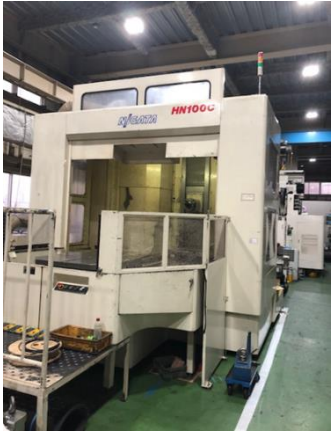
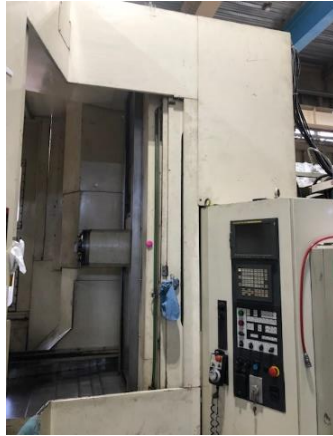
【Y-axis column needs to be removed; to be done at customer's factory】

The Y-axis column was found to be inaccurate due to peeling of the turcite used in the Y-axis column, and only the Y-axis column was brought to our factory to have the turcite replaced.

- ◆ Y-axis is removed, turcite is pasted, and the accuracy is again improved by Kisage (Scraping).
- ◆ Y-axis column (7 tons in weight) is removed at the customer's factory and brought to the in-house factory.
- ◆ Worn sliding surfaces on the Z-axis are corrected by on-site lapping
